**Problem:**

Premature gear wear

In applications that employ timing belts, proper support for shafting is key in obtaining optimal performance life of Slide-Rite® right-angle gearboxes

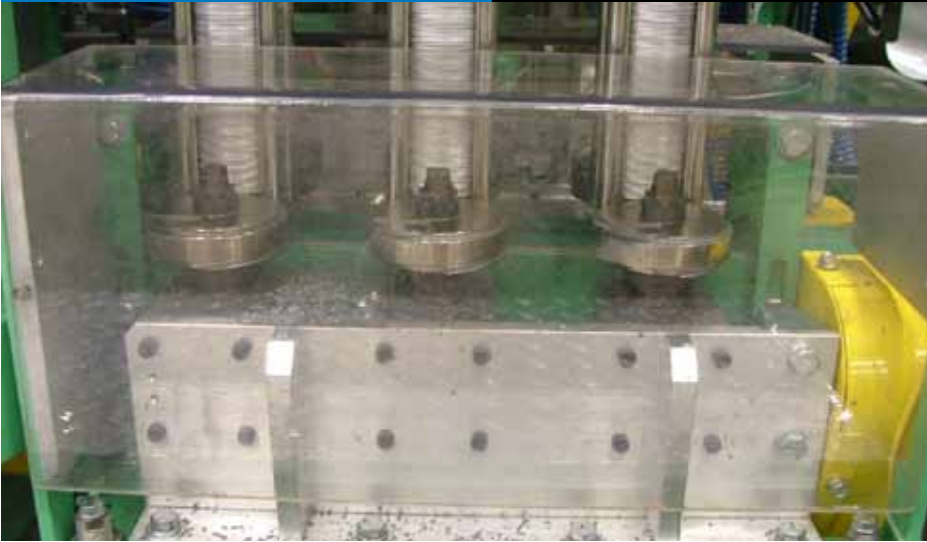
Excessive side loading applied to shafting by timing belt mechanism

A housing, containing a 1:1 ratio timing belt mechanism run by an AC motor, was mounted at one end of the horizontal shafting. The timing belt housing was mounted next to the machine enclosure and supported by one pillow block mount.

Additional mounting support added to shafting, elevates side loading effects on gears

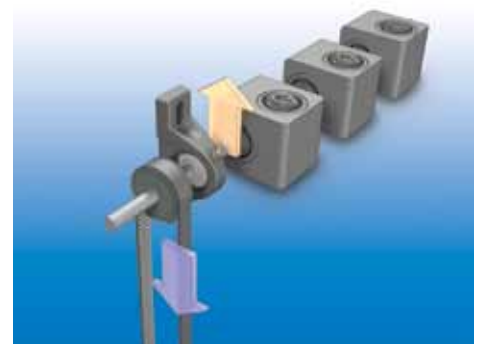
This illustration shows the mounting configuration of the existing timing belt mechanism, pillow block, and their relation to the first Slide-Rite gearbox on the shaft line.

In this application, the timing belt mechanism required a considerable amount of tension to keep it operating efficiently and the unit was under constant tensioning and tightening. Although the shaft end was supported by the pillow block mount, no support was being supplied to the length of the shafting running between the tensioning unit and the series of Slide-Rite gearboxes.

As tension increased on the timing belt, it created a pivot point between the timing belt housing and the shaft, resulting in a downwards pull. As a result, the gearboxes themselves were acting as bearings, (a function they are not designed to do) and the gears were taking the brunt of the side loading stress resulting in excess gear wear.

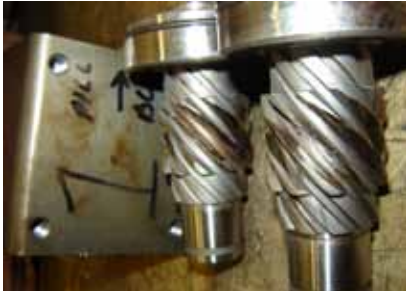
A closer look at the gear wear of the Slide-Rite units revealed a distinct pattern. The closer the units were to the timing belt mechanism, the greater the gear wear as shown in the photo below.

This photo shows the results of the side loading placed on the gears of the Slide-Rite unit closest to the timing belt case. Units that showed the least amount of gear wear were farthest from the timing belt mechanism.

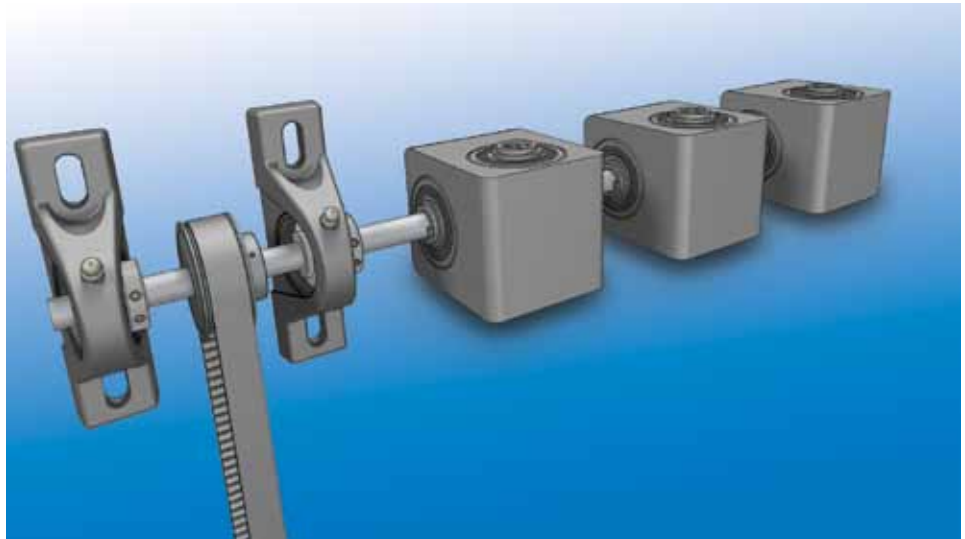
This illustration shows the placement of the additional pillow block mount on the shafting, eliminating the side loading effects to the gears of the Slide-Rite gearboxes.

The solution? Place another pillow block mount between the first gearbox and timing belt housing to support the length of shafting. The additional pillow

block removes the pivot point effect taking place, alleviates the side load, and the resulting stress placed on the gears of the Slide-Rite units.
